Upper French Broad River Watershed Restoration Plan

Transylvania and Henderson Counties
North Carolina

June 2022

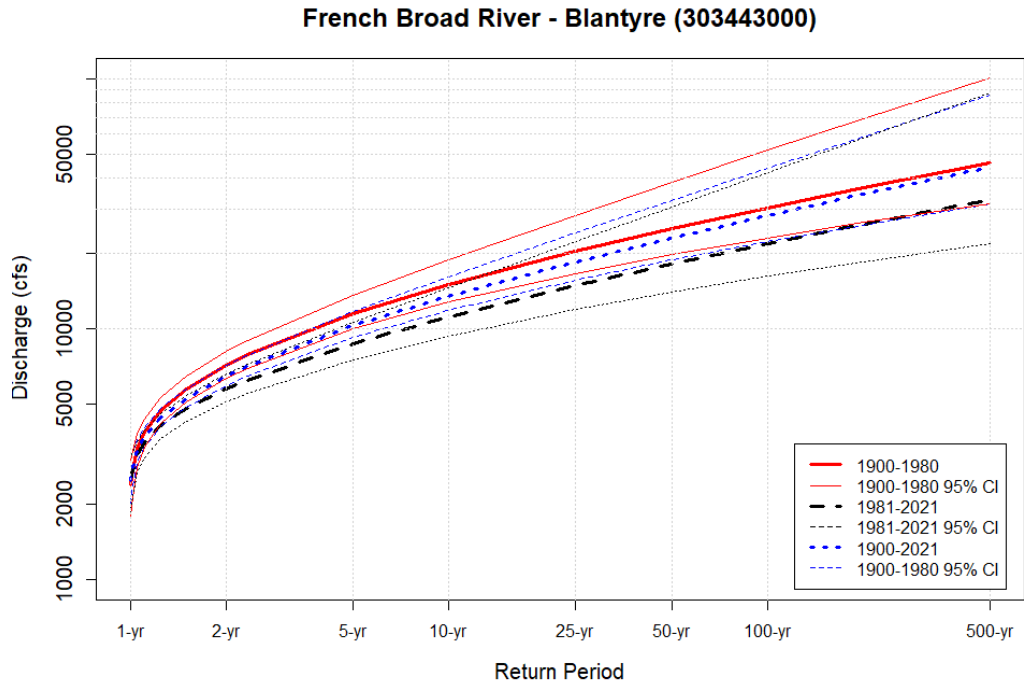
Figure B2. Flood Frequency Analysis for the French Broad River at Blantyre.

Summary of Findings: The magnitudes of discharges for a given return period were greater for the historical period than the current period for all three gage locations (Figure B1). However, the wide confidence intervals indicated no significant difference between the periods. Flood flow frequency analysis is very sensitive to extreme values and the highest peak discharges along the French Broad were recorded prior to 1980.

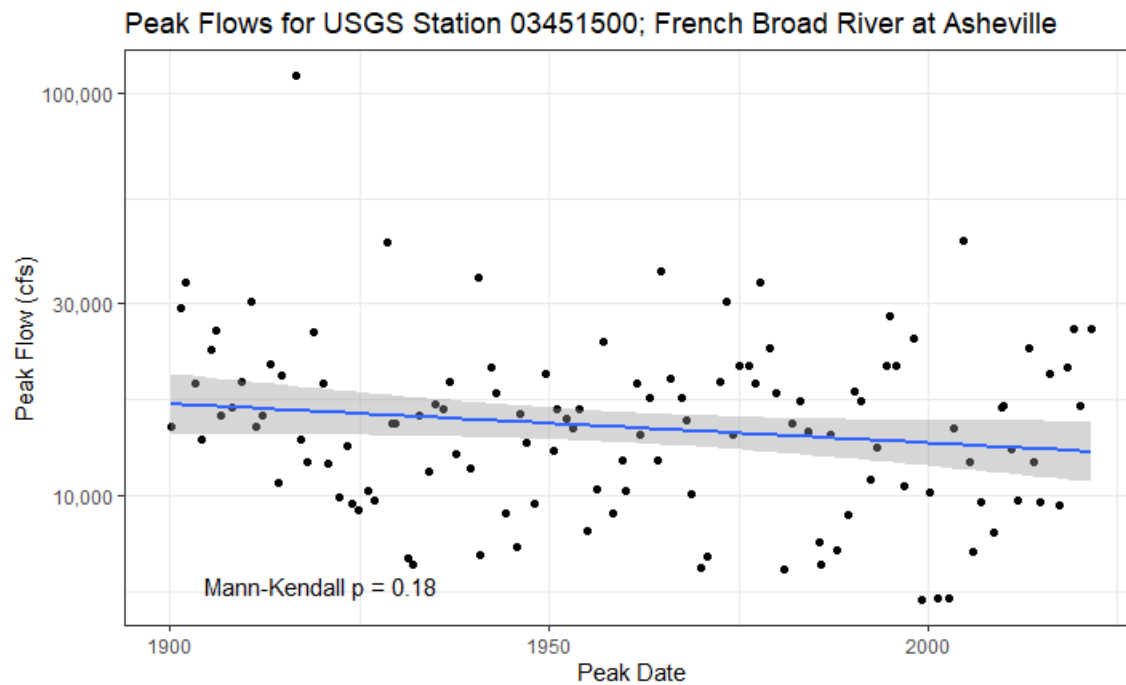
Figure B6. Peak flow record for the French Broad River at Asheville.

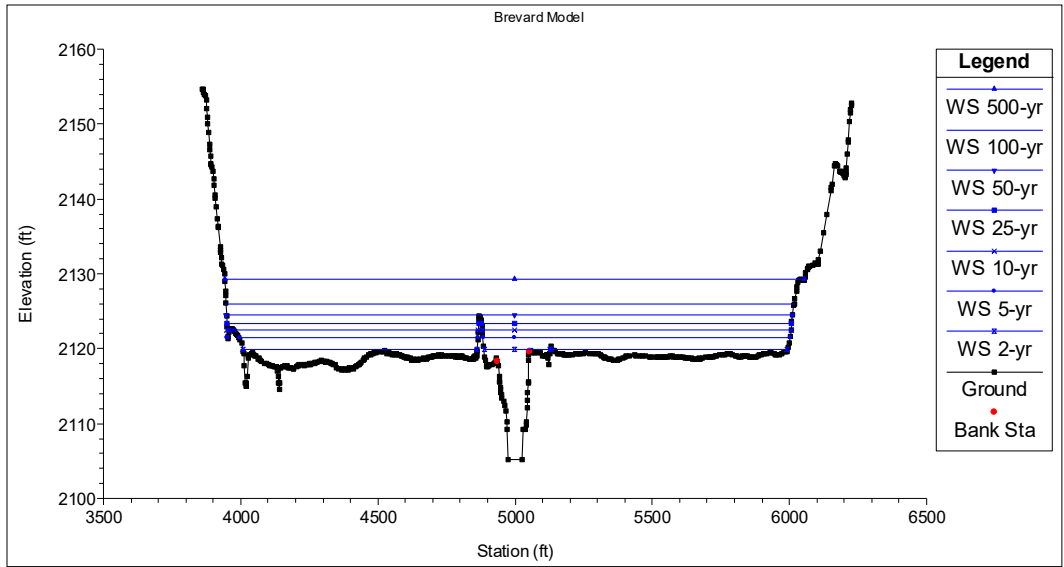
Figure B10. Brevard area model example Cross-section.

Summary of Findings: Two example cross sections are provided in Figures B9 and B10. Only relatively minor changes in the extent of flooding across the range of return periods simulated were noted – the floodplain is wide and flat and water spreads out to near the valley edges – even for the 2-yr and 5-yr events. The primary impacts of flooding for larger events is the difference in the depth of flooding.

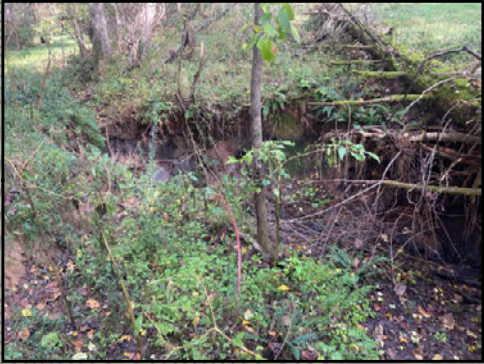
Stabilize existing head cut using grading, in-stream boulder structures, and vegetation.

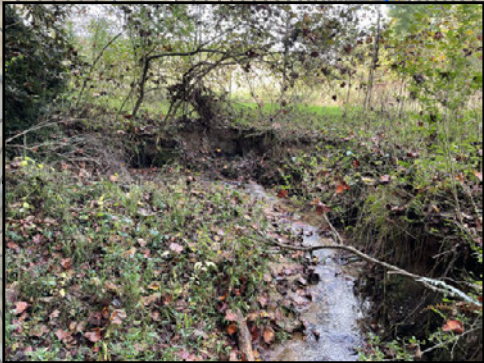
Stabilize existing minor bank erosion using grading and vegetation.

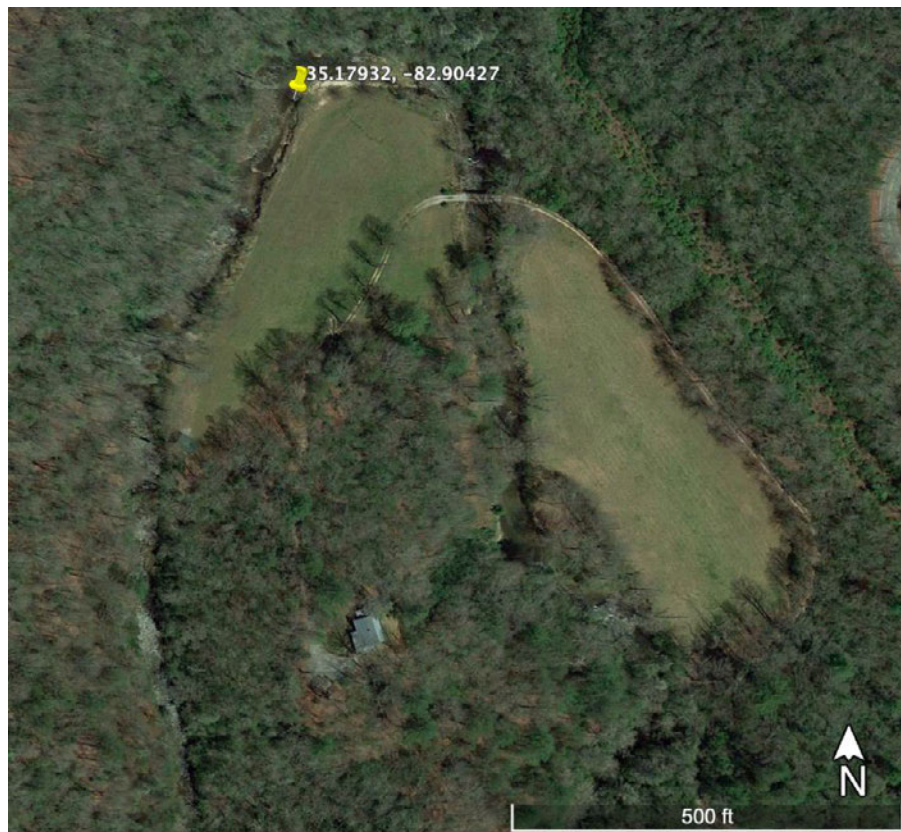
The report documents results of a stream restoration assessment on 2,000 linear feet of the West Fork French Broad River on private property in Transylvania County, NC, as shown on the aerial photo below:

Parcel ID:	Transylvania County PIN 8534-32-7703-000
Coordinates:	35.17932, -82.90427
Drainage Area:	13.6 square miles with 90% forested land
Annual Precipitation:	77 inches average
NCDEQ Classification:	B;Tr (Primary Recreation, Fresh Water; Trout Waters)

The stream enters the West side of the property flowing North through a forested area for 400 feet before entering the open field where the right descending bank and floodplain are mostly unforested. The stream flows around a horseshoe bend to the right for 900 feet before flowing under the driveway bridge. The stream continues flowing South along the East side of the property for 700 feet before leaving the property. The open field is prone to flooding during high flows, as evidenced by sandy deposition and woody debris remnants.

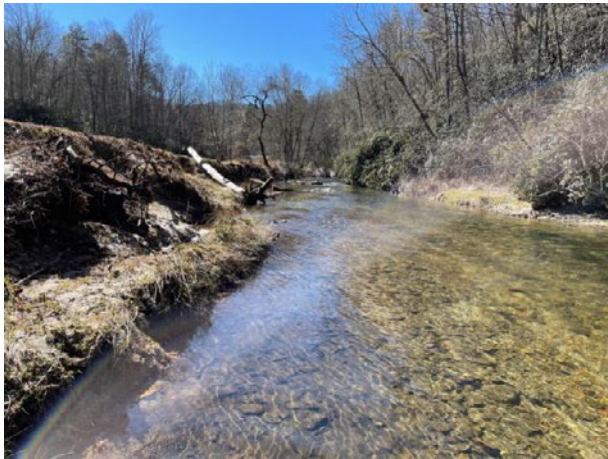
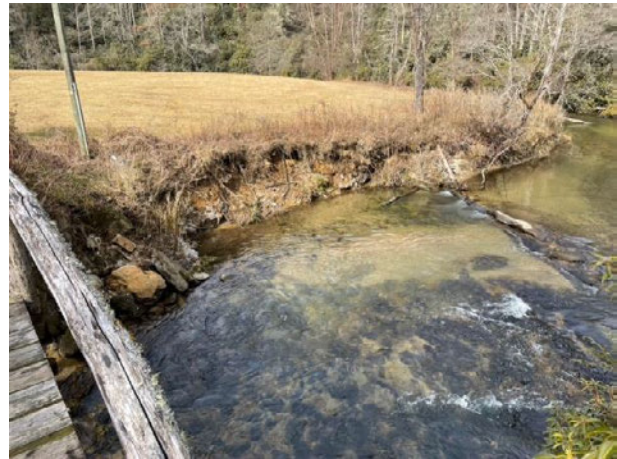
The existing stream stability and habitat condition range from excellent to poor based on streambank erosion, riparian buffer, and bedform diversity. Several areas of the right bank are eroding due to incision, lack of deep-rooted vegetation, and excessive near-bank shear stress as shown in photos below taken in January, 2021. The streambank immediately upstream of the driveway bridge is severely unstable as shown in the photo on the right taken from the bridge facing upstream.

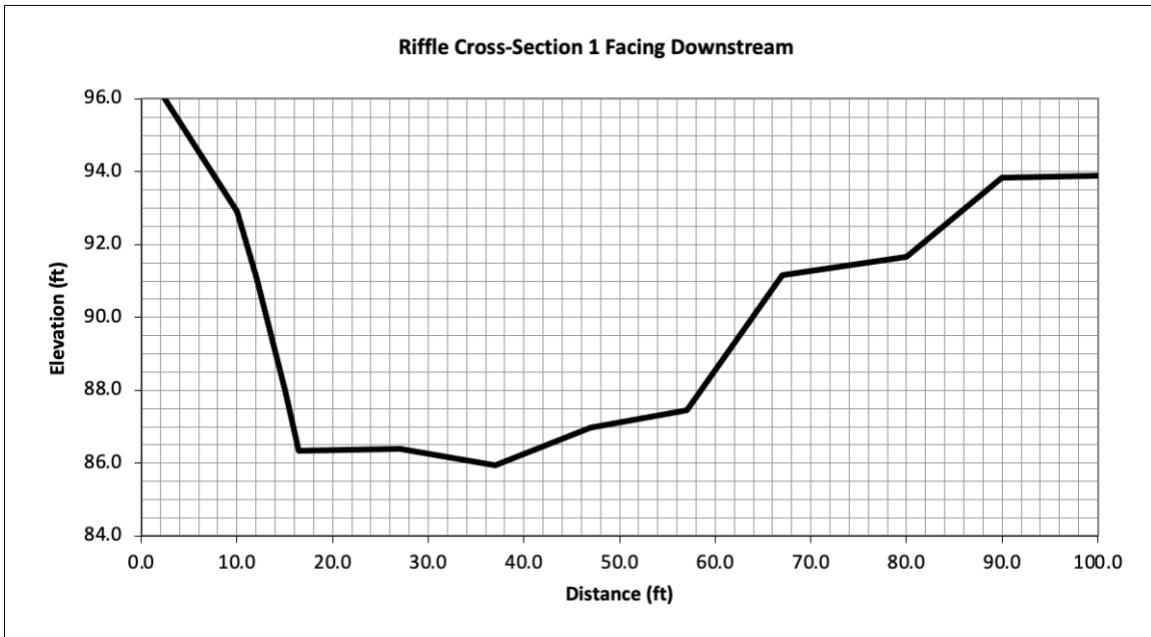
Cross-section 1 was measured at a stable stream location 140 downstream from the picnic pavilion. The diagram below shows the relative elevation of the ground above an arbitrary datum moving from left to right across the streambed. The deepest point on the cross-section, termed the “thalweg,” located at a distance of 37 feet from the left bank at an arbitrary elevation of 86 feet. At this cross-section, the left bank is solid rock and very stable. The right bank is mostly covered in trees and shrubs with some evidence of sandy deposition at the “bankfull” elevation of 91 feet. The measured area, width, and depth of the bankfull channel below this elevation are listed in Table 1 and used to calculate several morphology and hydraulic parameters.

Two stream channel cross-sections were measured in January, 2021, to determine geomorphic and hydraulic conditions as shown in the figures and table below. At each cross-section location, the elevation of the “bankfull” stage was identified as the sandy depositional surface along the channel where high flows fill the active channel and start to spread on the adjacent floodplain to dissipate hydraulic energy. This represents the natural stream process of maintaining equilibrium between erosion and deposition processes that continually cause minor adjustments to stream form. Where the floodplain is restricted by one or both tall banks, the channel is considered incised and susceptible to erosion during high flows.

The bankfull geomorphic and hydraulic parameters listed in Table 1 were calculated for the two cross-sections to document existing conditions and for comparison to naturally stable reference streams with the same drainage area in the same ecoregion. The measured bankfull cross-sectional areas are somewhat larger than reference streams, primarily because the channel is deeper with no access to a

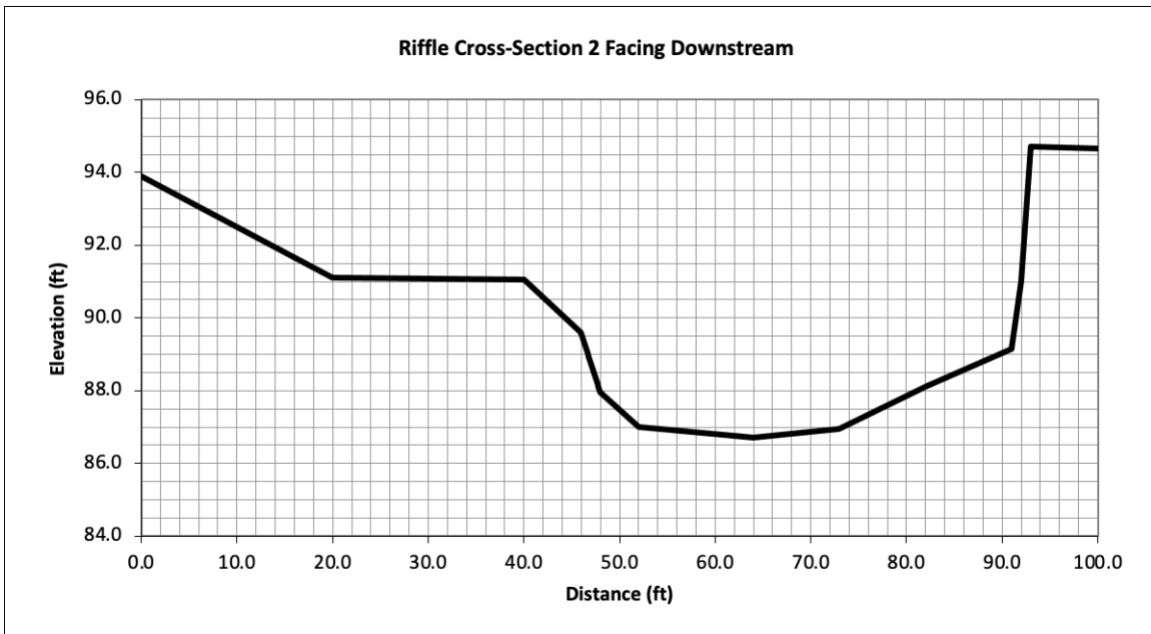
Cross-section 2 was measured at an unstable stream location 410 downstream from the picnic pavilion. The diagram below shows the flat sandy bankfull depositional bench on the left side and the eroding vertical bank on the right side. The bankfull stage is about 4 feet above the thalweg at this location, while the bank height on the right side is about 8 feet high, meaning that large flows will cause erosion due to high velocity, shear stress, and stream power which are all related to flow depth.

wide floodplain when flowing at the bankfull stage. This condition of vertical incision is indicated by the “bank height ratio” being greater than 1.0. The remedy for this condition is often excavation of a bankfull bench to allow streamflow exceeding bankfull stage to spread out and dissipate energy on a forested floodplain. The calculated hydraulic parameters of velocity, shear stress, and stream power are all substantially greater in the measured cross-sections than found in stable reference streams, meaning that the streambanks are regularly exposed to erosive forces.

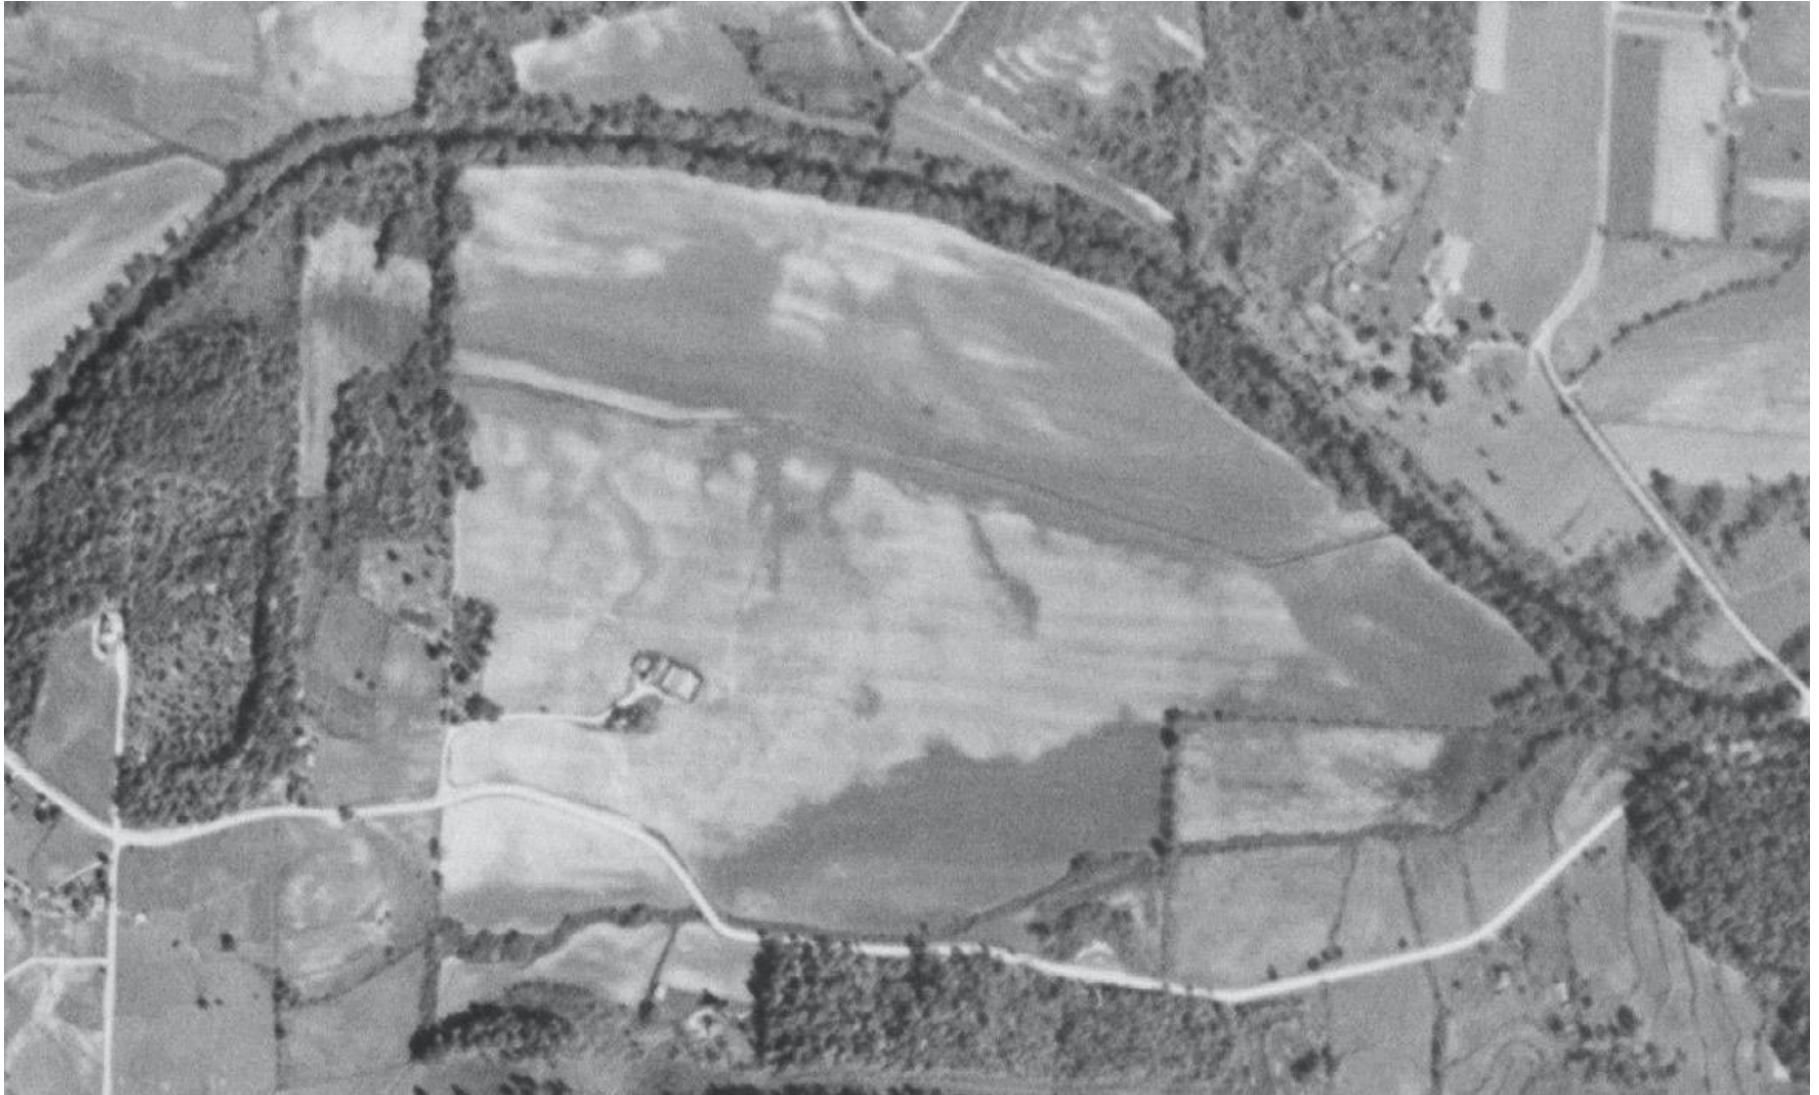
1956 Aerial Photo Showing Farm Land

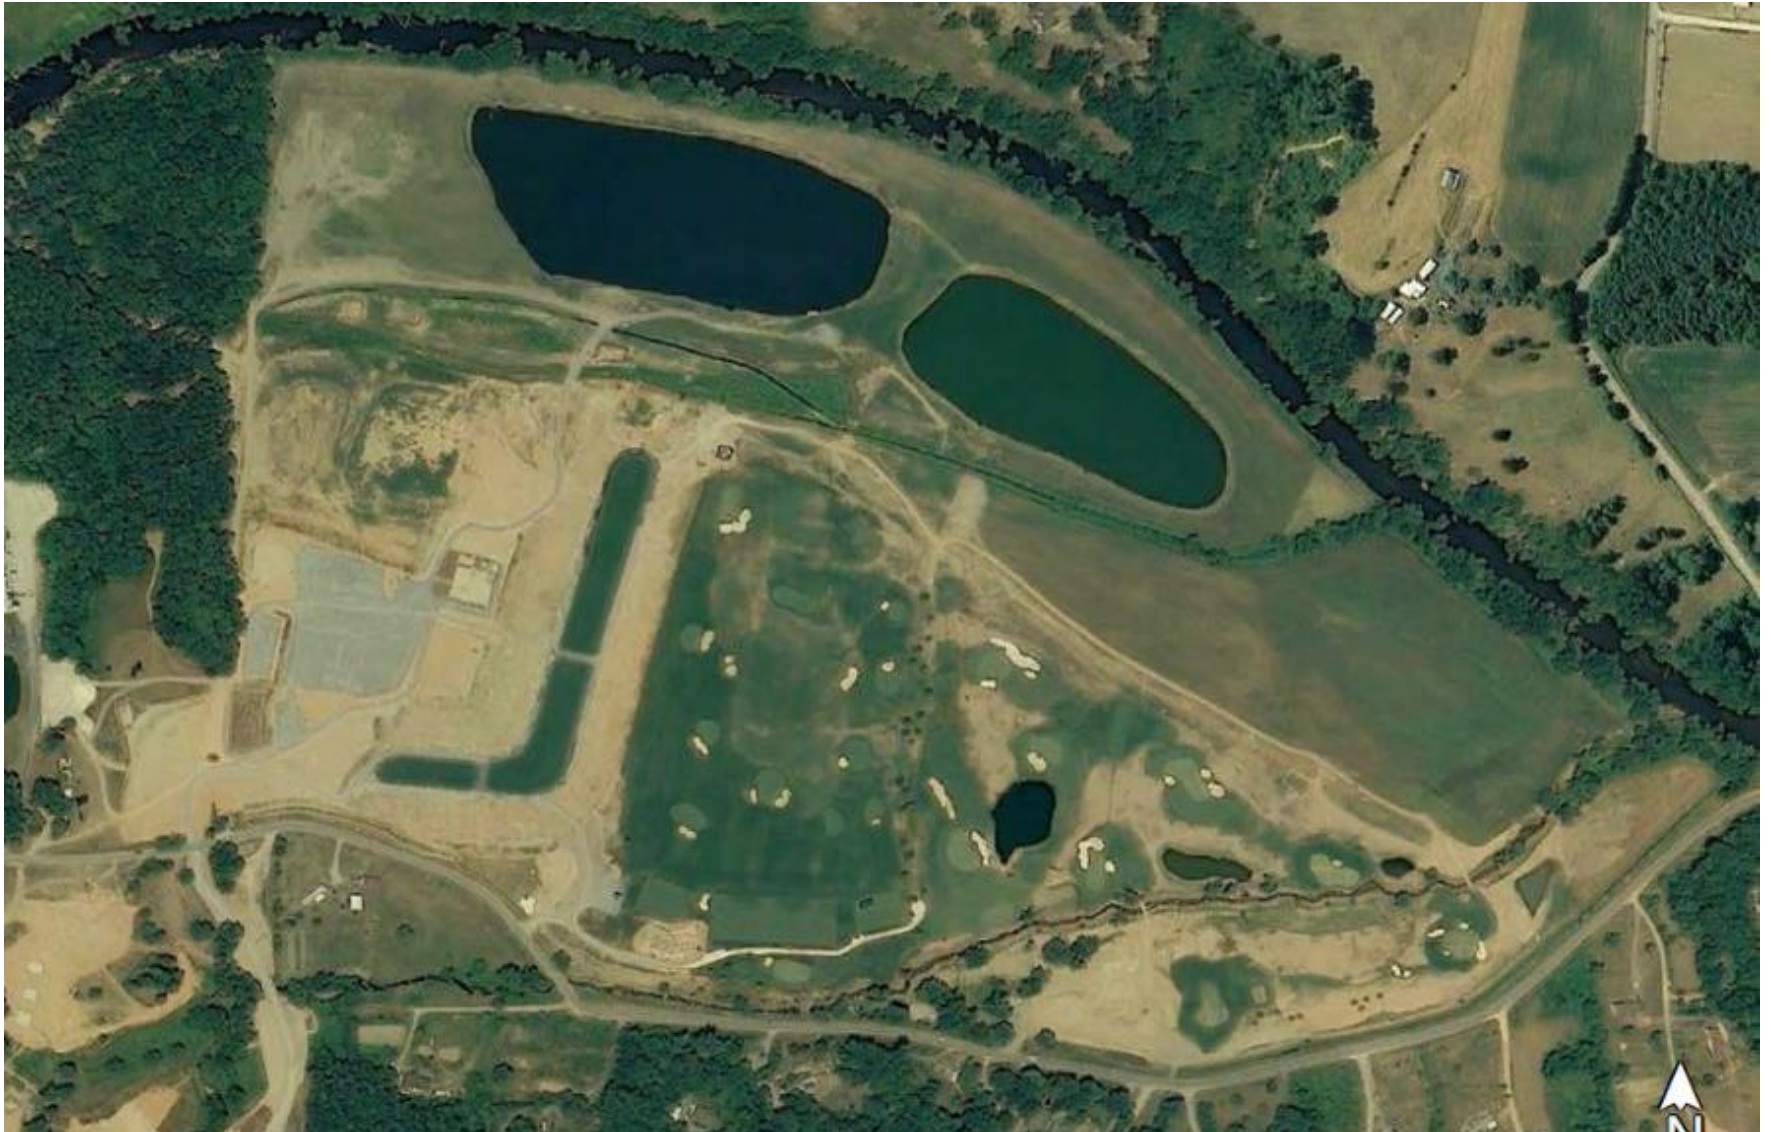
2008 Aerial Photo Showing Golf Course

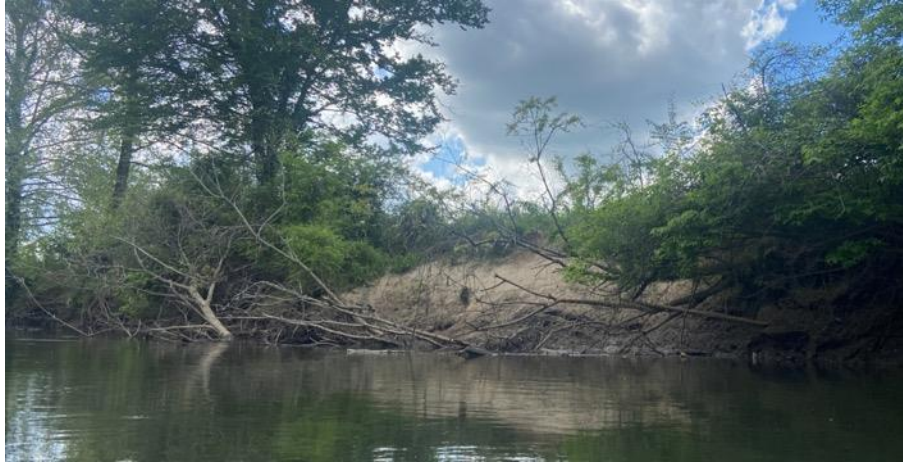
French Broad River Bank Erosion

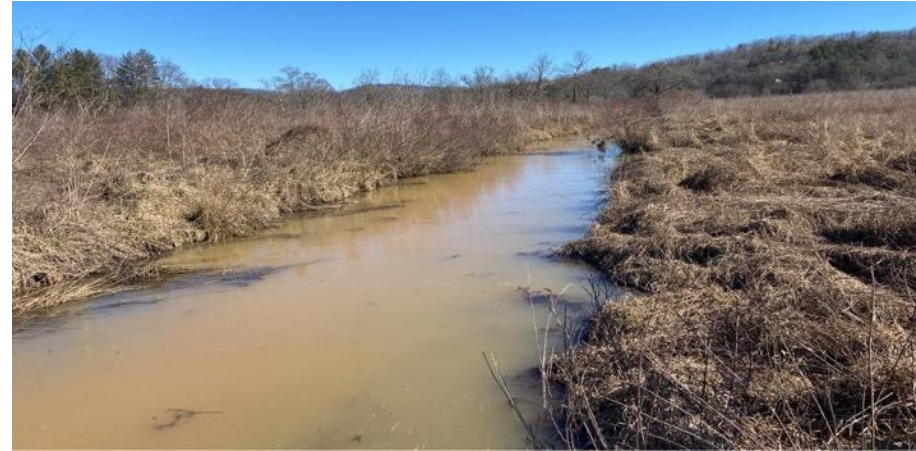
Linear Ditch Draining Wetlands

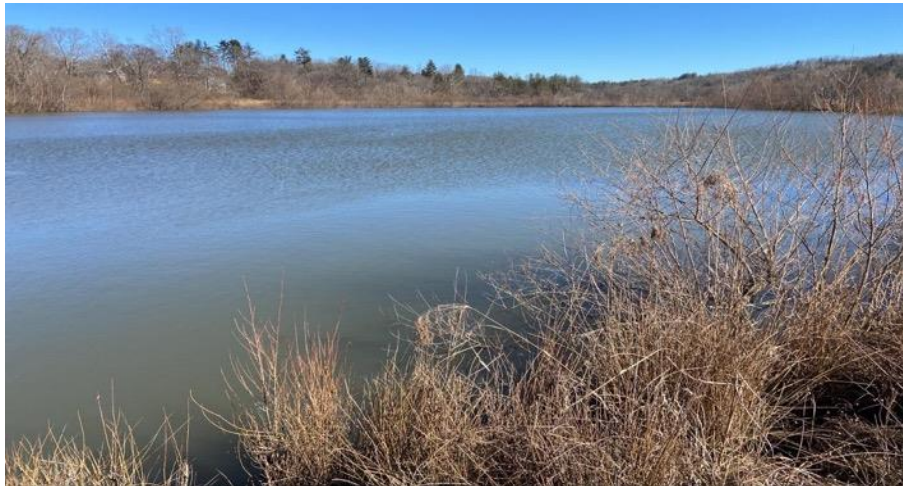
Pond on Floodplain

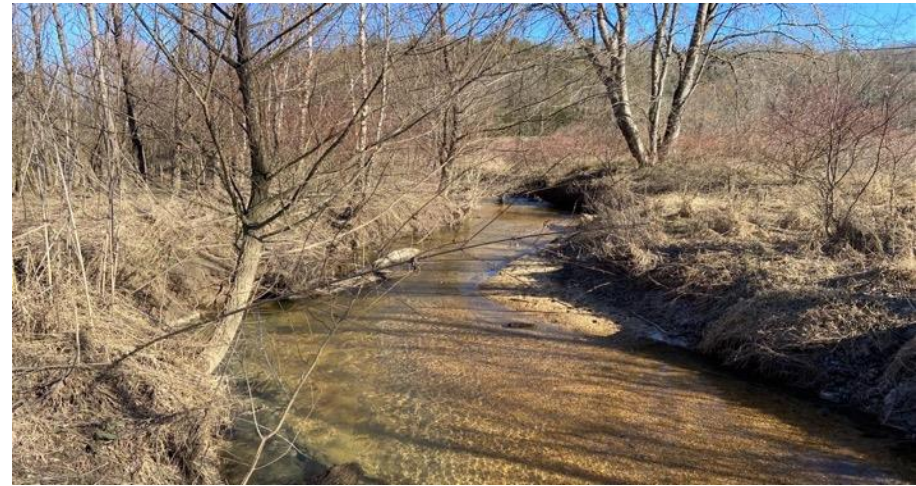
Little Willow Creek with Eroding Banks

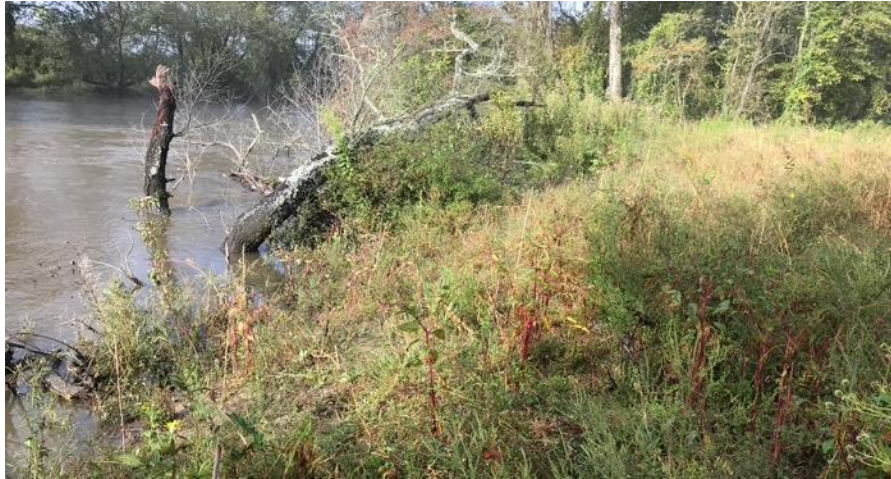
French Broad River Bank Stabilization

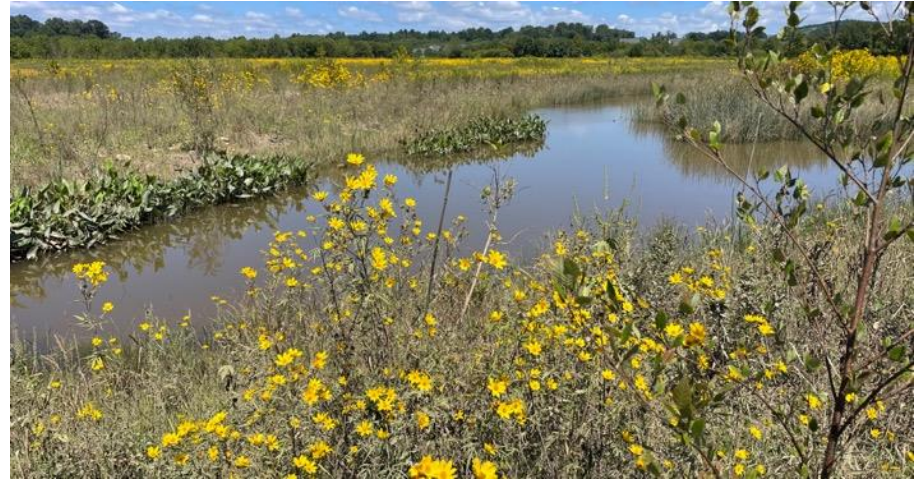
Meandering Linear Wetland

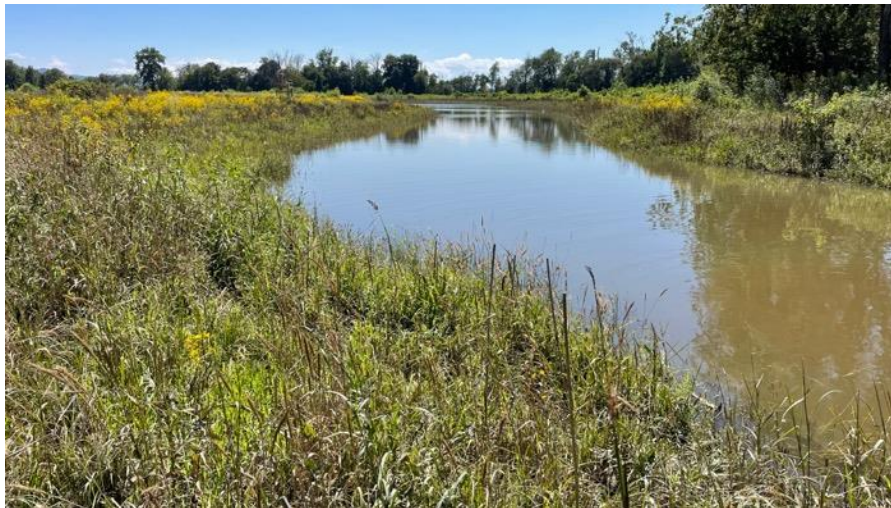
Muskie Habitat Sloughs (3)

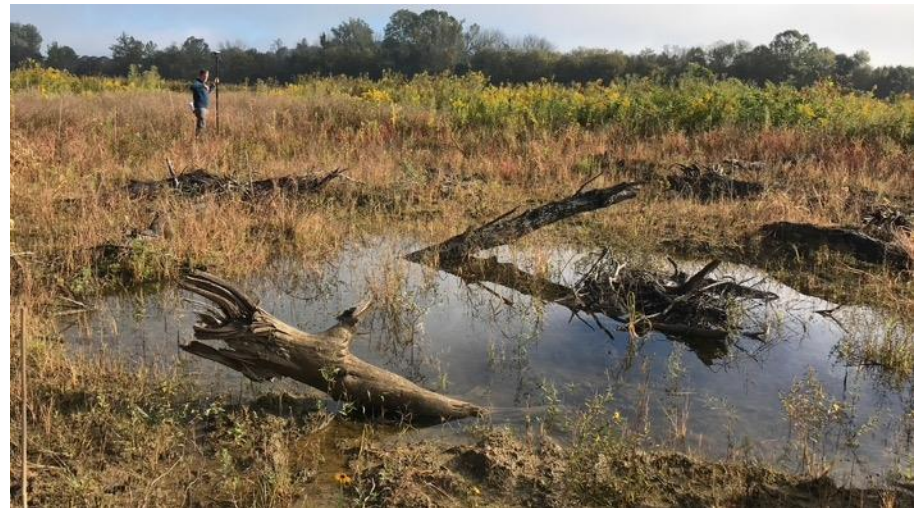
Wetland Depression Creation

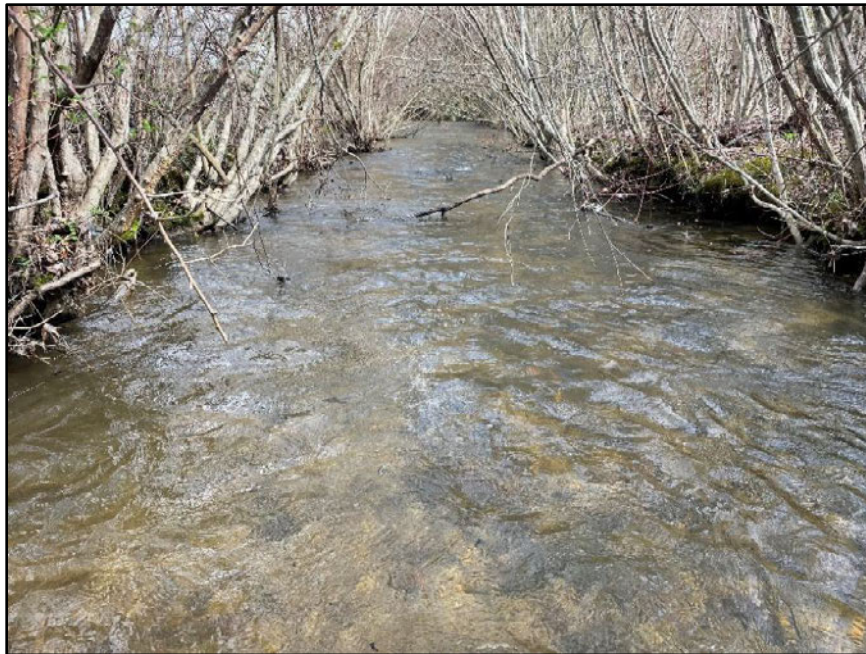
Figure 2. Reference-quality conditions on the Little River (within Reach 2).

Stream morphology: Observations of stream morphological parameters were made throughout the study area. These included dimensions derived from cross-section data, such as cross-section area, width, and mean depth. These dimensions were compared to reference conditions to understand to what degree this stream has departed from stable reference conditions. An area of reference quality river channel was observed within the study area, just downstream of the Robin Hood Road bridge, with a photo in Figure 2. The reference dimensions in this area are similar to what would be expected for the watershed size in the mountains of North Carolina. Reference cross-section dimensions can inform design choices for a restored stream during the engineering design process.

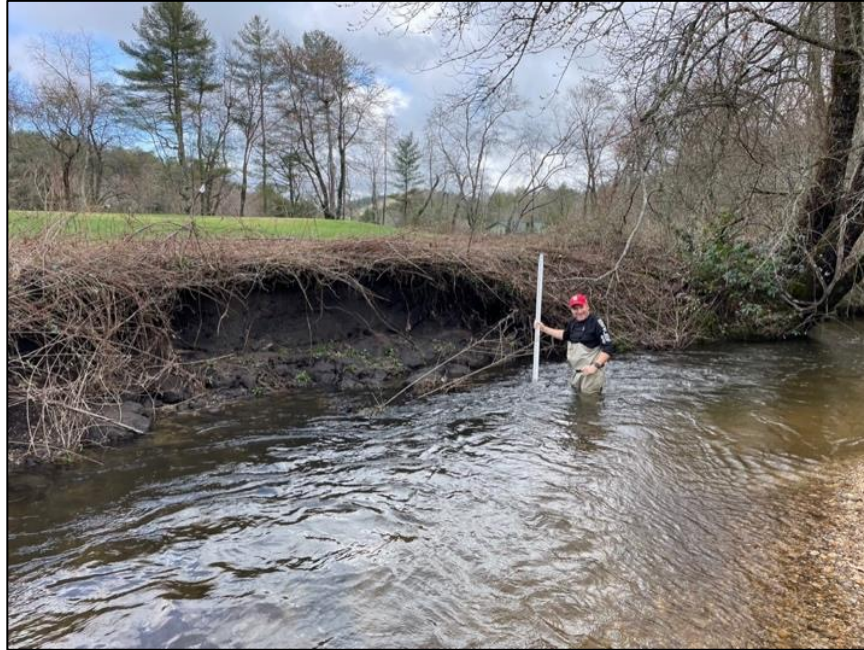
Figure 3. Representative view of impairment within Little River, Reach 1.

this crossing and continues 1,377 feet to the golf cart bridge near the eastern extent of the golf course. Photos of representative conditions within each reach are shown in Figures 3, 4, and 5.

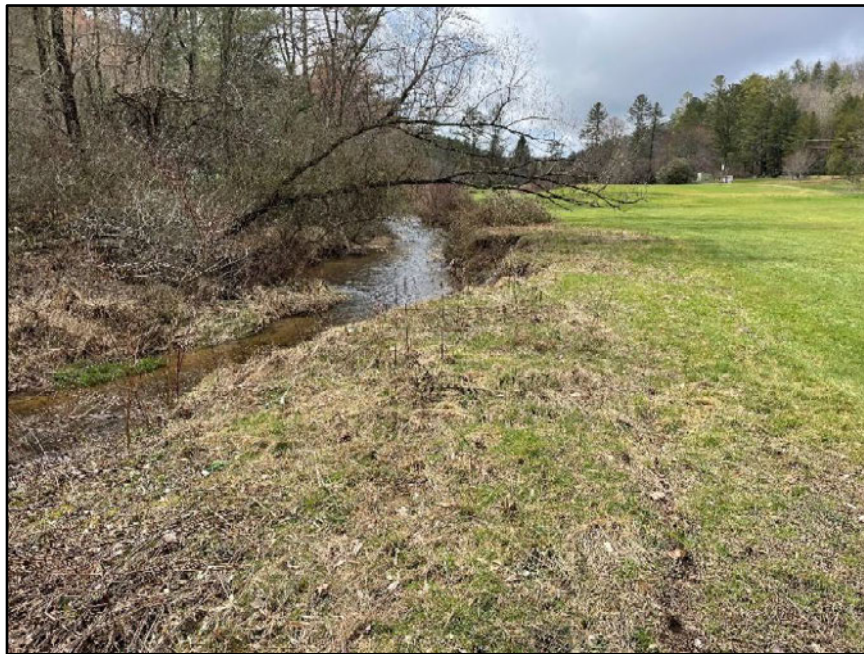
Figure 4. Representative view of impairment within Little River, Reach 2.

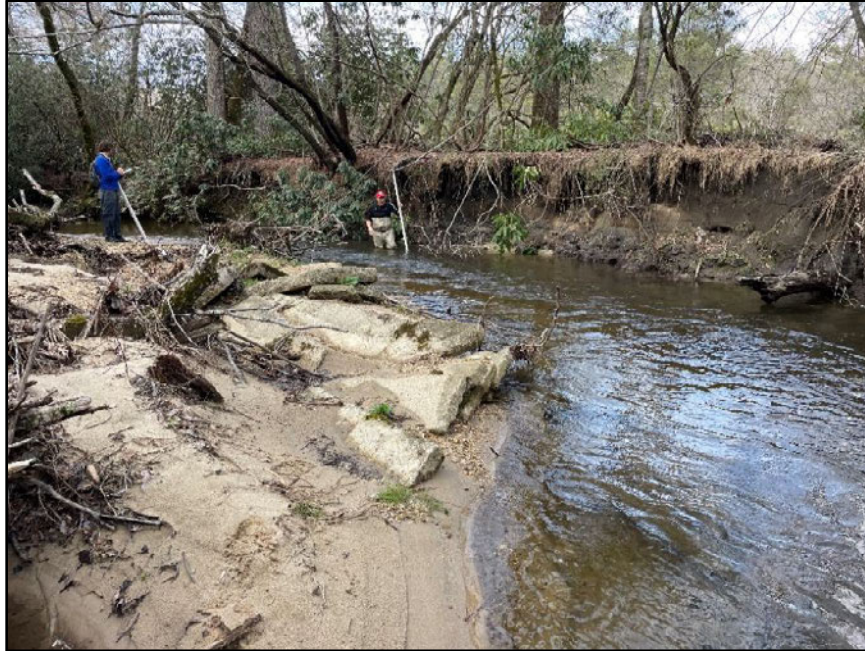
Figure 5. Representative view of impairment within Little River, Reach 3.

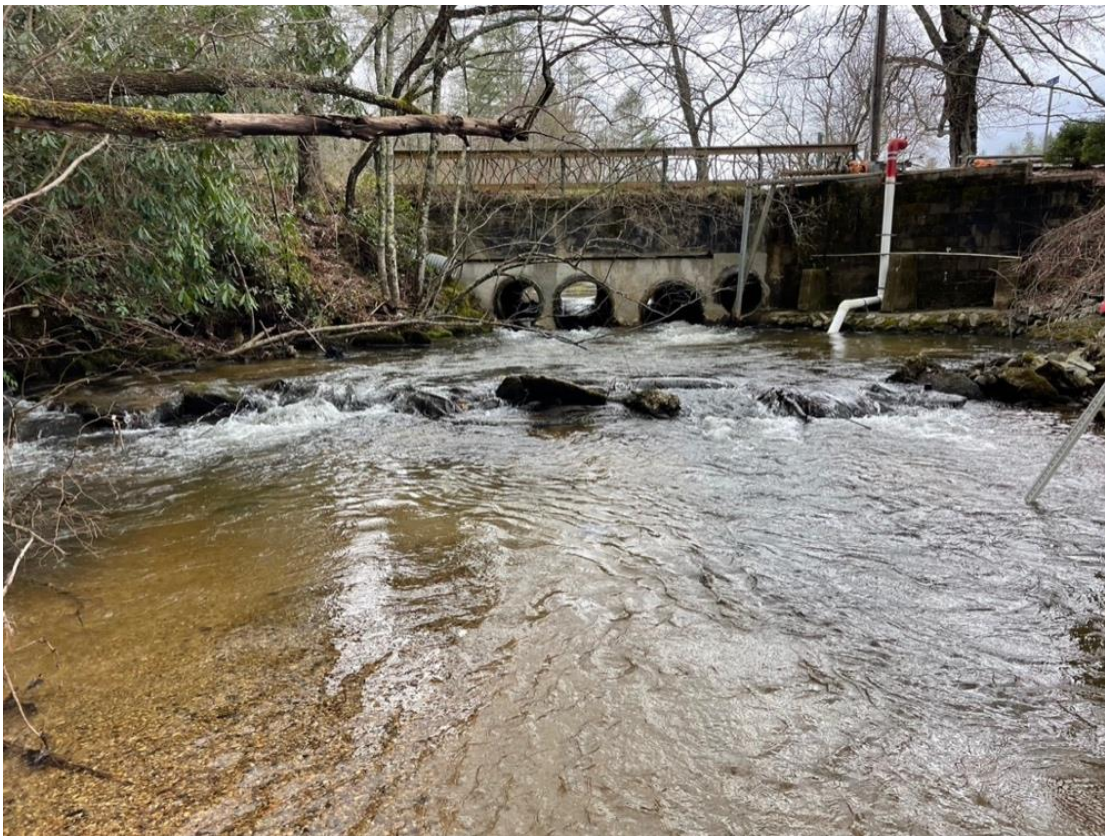
Figure 6. Cardinal Road Bridge Crossing.

The Cardinal Road bridge crossing is a special concern for ecological health and public safety (Figure 6). The crossing consists of several culverts which restrict flow during floods, increase water velocity causing erosion, and restrict the upstream passage of fish and other aquatic animals. This crossing should be considered for replacement with a free spanning bridge properly sized based on the bankfull width of the Little River.

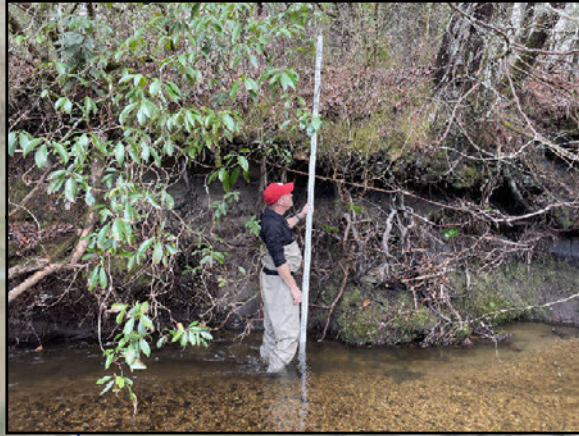
Site 12 (100 linear feet, right bank)
Estimated erosion rate: 6.5 tons/year

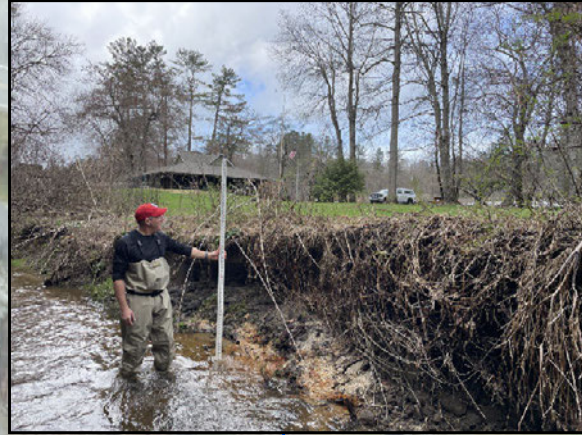
Site 14 (230 linear feet, left bank)
Estimated erosion rate: 7.0 tons/year

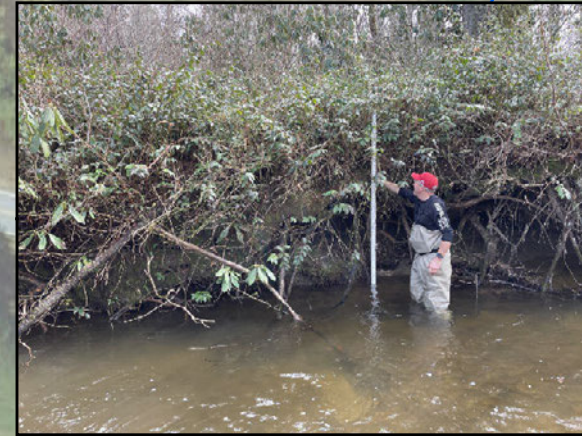
Site 16 (80 linear feet, right bank)
Estimated erosion rate: 5.0 tons/year

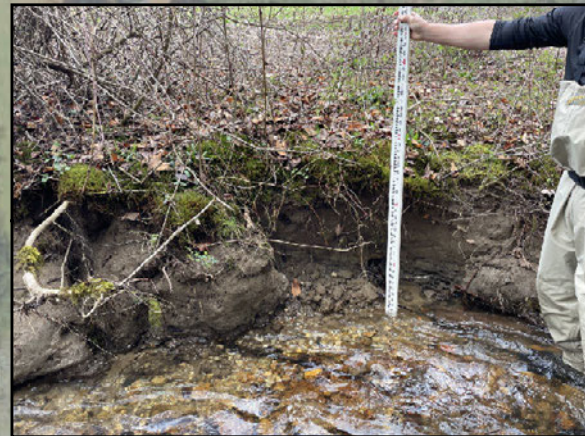
Site 13 (60 linear feet, left bank)
Estimated erosion rate: 0.9 tons/year

Site	Bank	Length (ft)	Height (ft)	BEHI	NBS	Erosion Rate (ft/yr)	Erosion Rate (cu ft/yr)	Erosion Rate (cu yd/yr)	Erosion Rate (tons/yr)	Erosion Rate (tons/yr/ft)
1	Left	50	4.5	Very High	High	0.90	202.5	7.5	8.2	0.16
2	Left	150	2.5	High	Moderate	0.15	56.25	2.1	2.3	0.02
3	Left	100	3	High	High	0.20	60	2.2	2.4	0.02
4	Left	120	2	High	Moderate	0.15	36	1.3	1.5	0.01
5	Left	120	2	High	Moderate	0.15	36	1.3	1.5	0.01
6	Right	80	2.5	High	High	0.20	40	1.5	1.6	0.02
7	Left	100	2.5	High	Moderate	0.15	37.5	1.4	1.5	0.02
8	Left	100	2.5	High	High	0.20	50	1.9	2.0	0.02
Reach 1 Total		820						19.2	21.0	0.015
9	Left	40	2	High	Moderate	0.15	12	0.4	0.5	0.01
10	Left	180	4.5	High	High	0.20	162	6.0	6.6	0.04
11	Left	100	4.5	High	Moderate	0.15	67.5	2.5	2.7	0.03
Reach 2 Total		320						8.9	9.8	0.007
12	Right	100	8	High	High	0.20	160	5.9	6.5	0.06
13	Left	60	2.5	High	Moderate	0.15	22.5	0.8	0.9	0.02
14	Left	230	5	High	Moderate	0.15	172.5	6.4	7.0	0.03

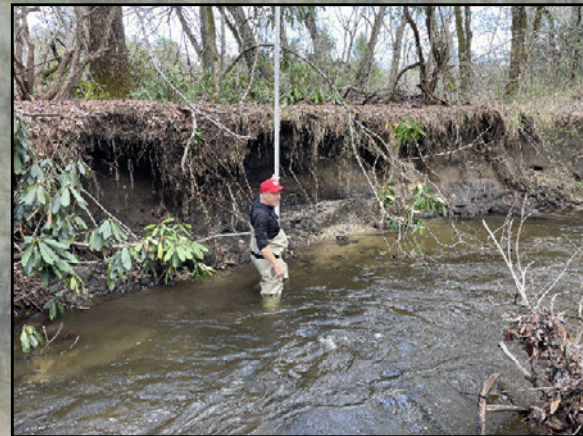
Site 15 (60 linear feet, left bank)
Estimated erosion rate: 17.4 tons/year

15	Left	60	6.5	Very High	Very High	1.1	429	15.9	17.4	0.29
16	Right	80	5.5	High	Very High	0.28	123.2	4.6	5.0	0.06
17	Left	130	6.5	High	Very High	0.28	236.6	8.8	9.6	0.07
18	Right	40	5	High	High	0.20	40	1.5	1.6	0.04
19	Left	20	5.5	High	Very High	0.28	30.8	1.1	1.2	0.06
20	Right	50	8	High	High	0.20	80	3.0	3.2	0.06
21	Left	80	7	Very High	Very High	1.1	616	22.8	25.0	0.31
Reach 3 Total		850						70.8	77.5	0.056

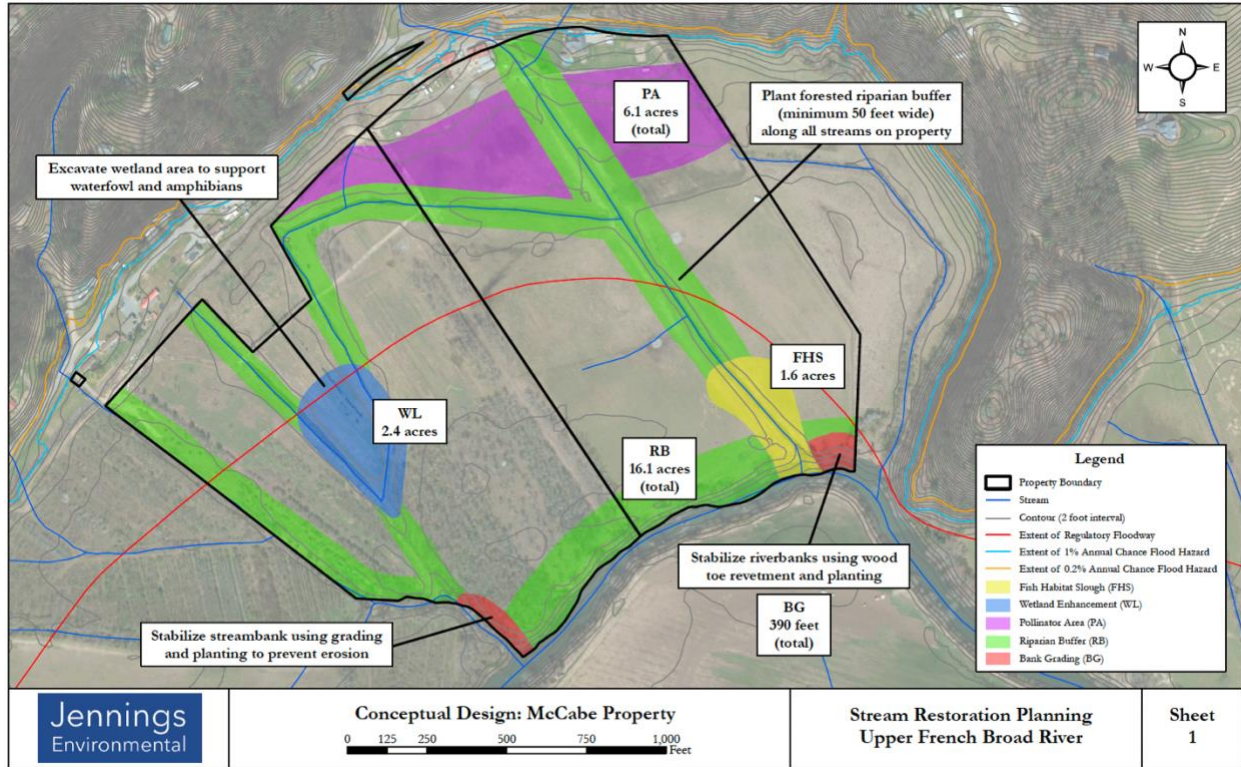
McCabe Property: This project addresses approximately 45 acres of land in the floodplain of the French Broad River. The proposed restoration project will include:

- French Broad River bank stabilization along 390 linear feet of left bank.
- River buffer enhancement 300 feet from bank totaling 16.1 acres.
- Stream restoration totaling 1,100 linear feet on a first-order tributary flowing through this parcel.
- Wetland enhancement totaling 2.4 acres associated with ditch plugging and planting.
- Excavate a fish habitat slough (approximately 1.6 acres in area) that is hydrologically connected to the French Broad River.
- Create floodplain forest and pollinator areas in existing open areas on the property.
- Manage invasive plants throughout the project area.

Estimated costs for this project are \$700,000 for construction and planting in addition to \$140,000 for engineering and permitting.
